Manhole Inspection Summary

Manhole # S17QQ1029MH

Location Address: **5028 YELLOWWOOD AVE**

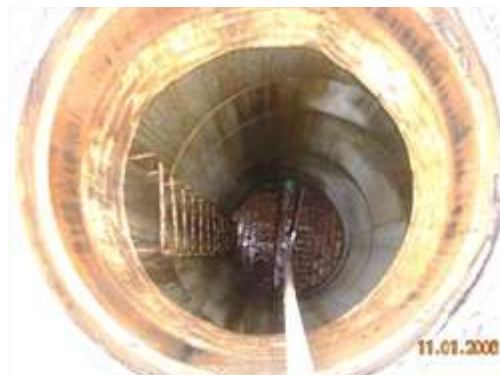
Top View

Bench debris.

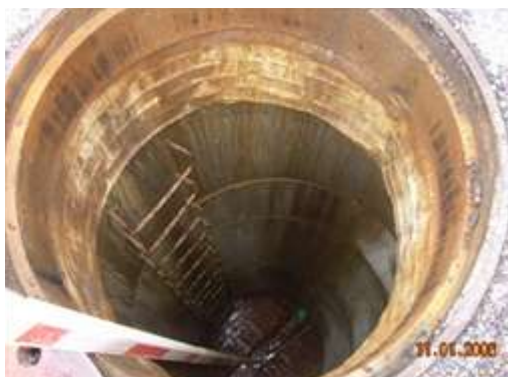
Defect

Frame leaks. Adjustment, Corbel and Barrel infiltration.

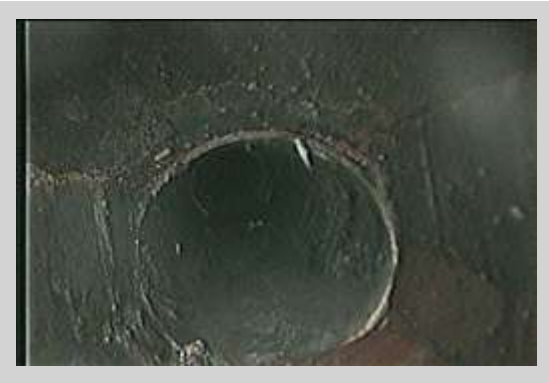
8 in. Circular Gravity Sewer Pipe Out @ 12 O'Clock

Infiltration: **None** Pipe Seal Cond: **Cracked**

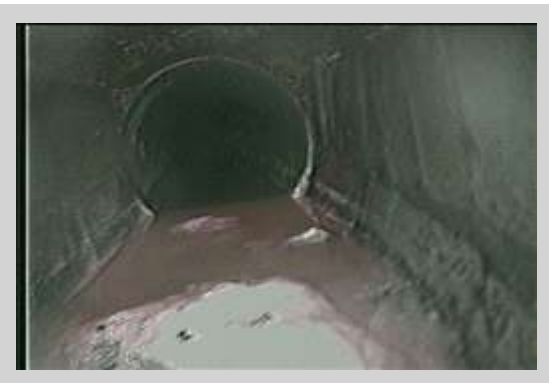
8 in. Circular Gravity Sewer Pipe In @ 6 O'Clock

Deposits: ☐ None ☒ **Mud** ☐ Sludge ☒ **Debris** ☒ **Grease**

Silt Depth: **0.5** (in.) Deposits Extent: **Light**
